## THE GEO-ENVIRONMENTAL MENACE BY FLOODING AROUND IKWUANO AREA, SOUTHEASTERN NIGERIA

1. Uzoegbu, M. U. and 2. Agbo, C. C.

<sup>1,2</sup> Department of Geology, College of Physical and Applied Sciences, Michael Okpara University of Agriculture, Umudike, PMB 7267, Umuahia, Abia State.

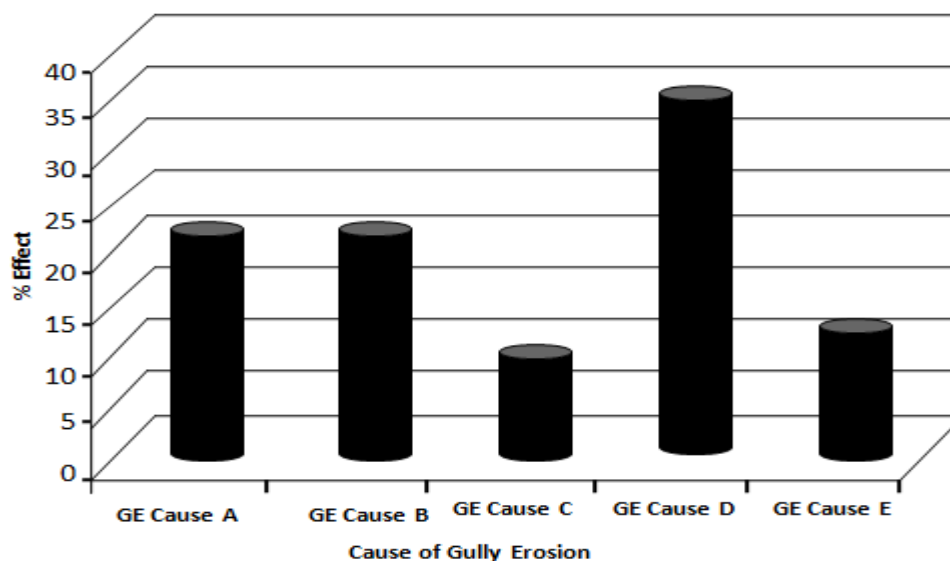
Fig. 3: Percentage effect of the causes of Gully erosion in Ikwuano LGA (After Onyelowe, 2017).

Fig. 3 also showed the gully erosion diagrammatical effects of the different identified causes A to E in Ikwuano Local Government Area of Abia State. It could be deduced that again GE-Cause D; dumping of municipal solid waste on drain facilities was predominant in effects. This also goes to show that this does not only deface the environment, but poses lots of geoenvironmental hazards ranging from pollution and emission of poisonous metal gases to the decay it causes on the transportation facilities on a daily basis. And this adversely affects the lives of the people (Onyelowe, 2017).

For the purpose of handling, the identified causes of gully erosion in Abia State were labeled GE-Cause A: lack of drain facilities, GE-Cause B: badly constructed road pavements, GE-Cause C: negligence to rainfall and runoff volume during the design stage of drains, GE-Cause D:

dumping of municipal solid waste on drain channels and GE-Cause E: wrongly located building structures as a result of wrong planning, (where GE is Gully Erosion) and the responses from the affected local governments in Abia state were evaluated in percentage (Onyelowe, 2017).

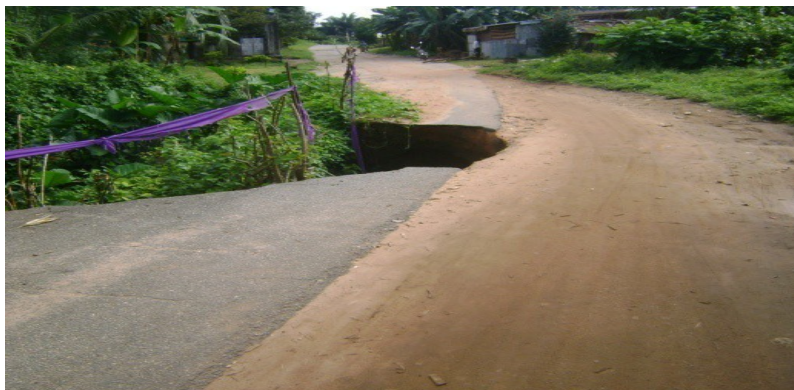
Picture 1: Failed portion of road site at Ndoro-Itunta (Elemaga-Ibere) road.

However some parts of the roads at the three sites (Numan town, New Demsa, Farei and Imbru failed probably because of poor work done during construction. The road at Dowaya site failed probably because the values of result exceed the British standard Institution (BS) and (AASHTO) recommended limits (Pictures 1 and 2).

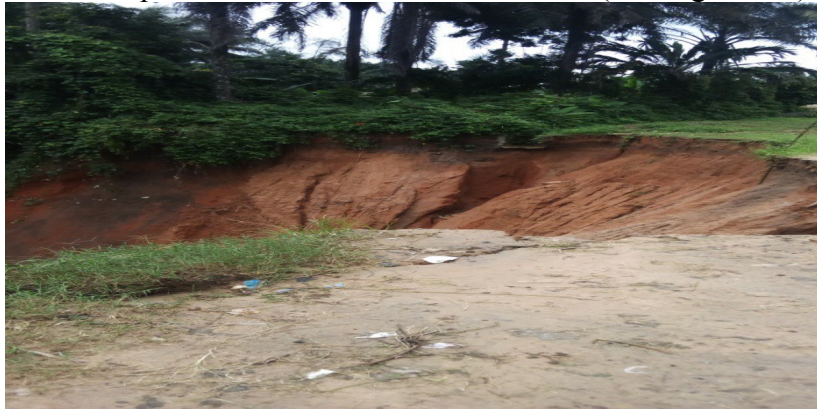
Picture 2: Failed portion of road site at Ariam-Usaka ring (Amaegbu-Ariam) road.
